Inspection Report

Property Address:
9517 River Otter Dr
Fort Myers FL 33912

MEF Home Inspections LLC

Date: 10/27/2026	**Time:** 03:00 PM	**Report ID:** 20261027-9517-River-Otter-Dr
Property: 9517 River Otter Dr Fort Myers FL 33912	**Customer:** Visionary Holdings	**Real Estate Professional:** Katie Martin

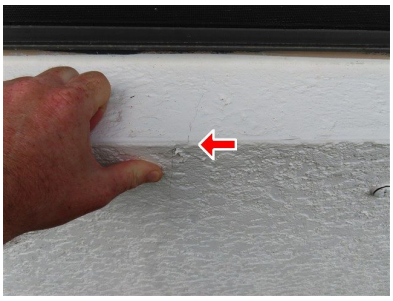
5.4 Item 1 (Picture)

Minor stucco cracks under windows on left side of dwelling.

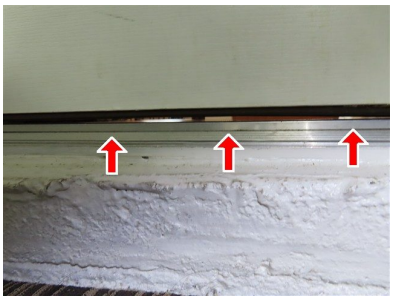
7.6 Item 1 (Picture)

Sweeps at garage door were poorly installed leaving a large gap. A sweep is a rubber strip that attaches to the bottom of a door to seal the gap between the bottom of the door and the threshold. Sweeps should be replaced to help prevent air/heat leakage that will increase heating/cooling costs and reduce home comfort. Correction should be made by a qualified contractor.

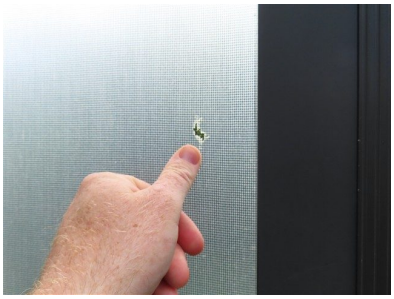
14.0 Item 1 (Picture)

Minor damage to screening on right side pool cage door.
