Uniform Mitigation Verification Inspection Form

Inspection Date: 12/4/2024		
Owner Information		
Owner Name: Jenine Loving		Contact Person:
Address: 9517 River Otter Dr		Home Phone:
City: Fort Myers	Zip: 33912	Work Phone:
County: Lee		Cell Phone:
Insurance Company:		Policy #:
Year of Home: 2015	# of Stories: 2	Email:

Inspectors Initials MF **Property Address** 9517 River Otter Dr, Fort Myers, FL 33912

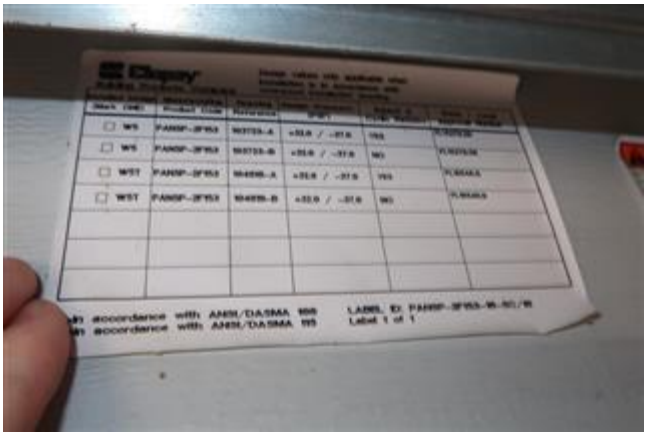
Opposing side of single wraps
